THE CONTRIBUTION OF CLIMBING PLANTS TO SURFACE ACIDITY AND BIOPITTING EVIDENT AT THE UNIVERSITY OF OXFORD BOTANIC GARDEN, UK

M. J. Thornbush

ABSTRACT: Fieldwork was executed at the University of Oxford Botanic Garden located in central Oxford, UK in order to examine enlarged holes on the surface of a c. 380-year-old border wall comprised of Headington stone. There are bee hotels located in the walled section within the Garden, where it is thought that red mason bees are responsible for the holes. Manual counts of the holes, however, revealed no clear spatial trend of an increasing frequency closer to the bee hotels. Supplementary research was conducted in order to ascertain the cause of these noticeable masonry holes. A digital pH meter was employed on-site with runoff collection of distilled water to measure surface acidity, which could be responsible for initial pitting on these limestone walls that could then be exploited (and enlarged) by bees. However, these large holes, measuring up to 23.41 mm across, could not be the product of environmental acidity alone, as due to organic acids released by (climbing) plants also found in this area. This multivariate problem is considere

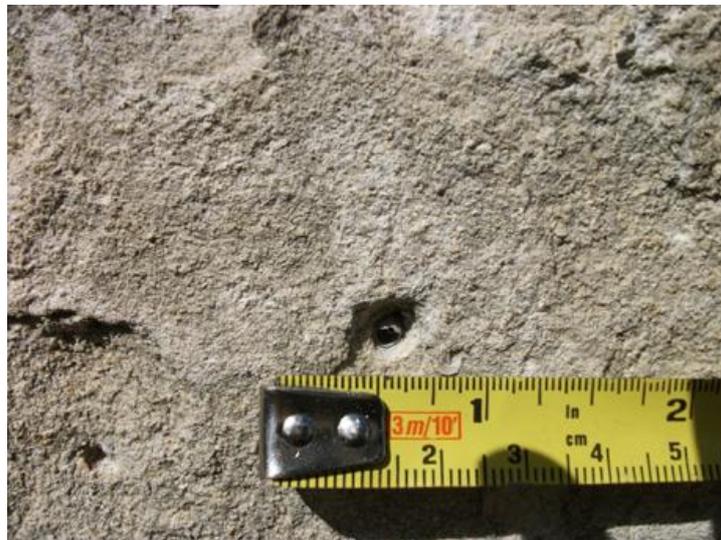
Fig 1a: Enlarged pits visible on the border wall at the University of Oxford Botanic Garden

The purpose of this study was to examine the causes for enlarged pits visible on an old wall at the University of Oxford Botanic Garden, UK (Fig:1a). Their formation is predominantly due to chemical weathering due to dissolution in an acidic environment, including surface acidification from rootlets (as part of bioweathering) on varieties of ivy found on some of these border walls (Fig:1b). Climatic conditions are also possibly involved in the formation of these pits, affecting physical weathering. Add: It is also important to consider the actual rock type and fabric, as this affects weathering rates and forms. Headington freestone is a buff-colored ashlar used on the border walls, spanning 100 m and up to 5 m in height, that was used in historical buildings in Oxford. This limestone is known to become encrusted with black crusts and is susceptible to blistering. Even though pits can also develop on this stone in acidic conditions, these holes are larger than usual pits visible on limestone walls from dissolution alone. It is possible that existing pits (formed due to acidification) were enlarged by physical weathering as a component of bioweathering (such as burrowing), as insects (such as bees) are known to inhabit holes on walls (Fig:1c).

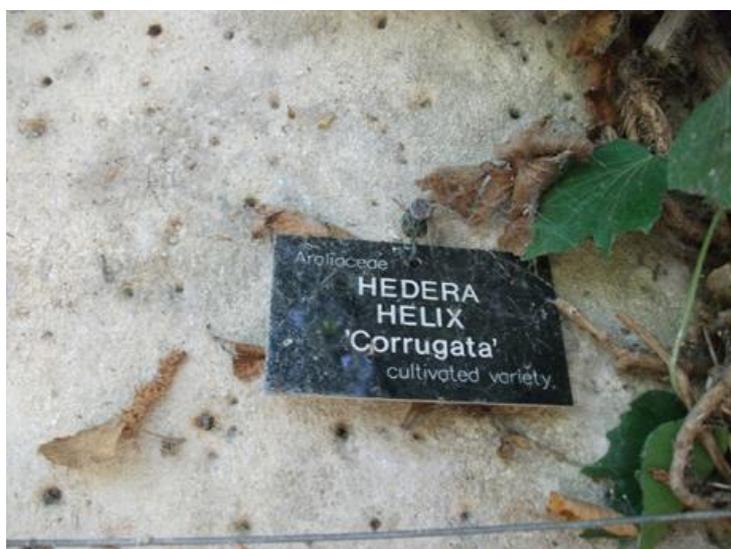
Fig 1b: English ivy (*Hedera helix*) growing along the back (north-facing) wall

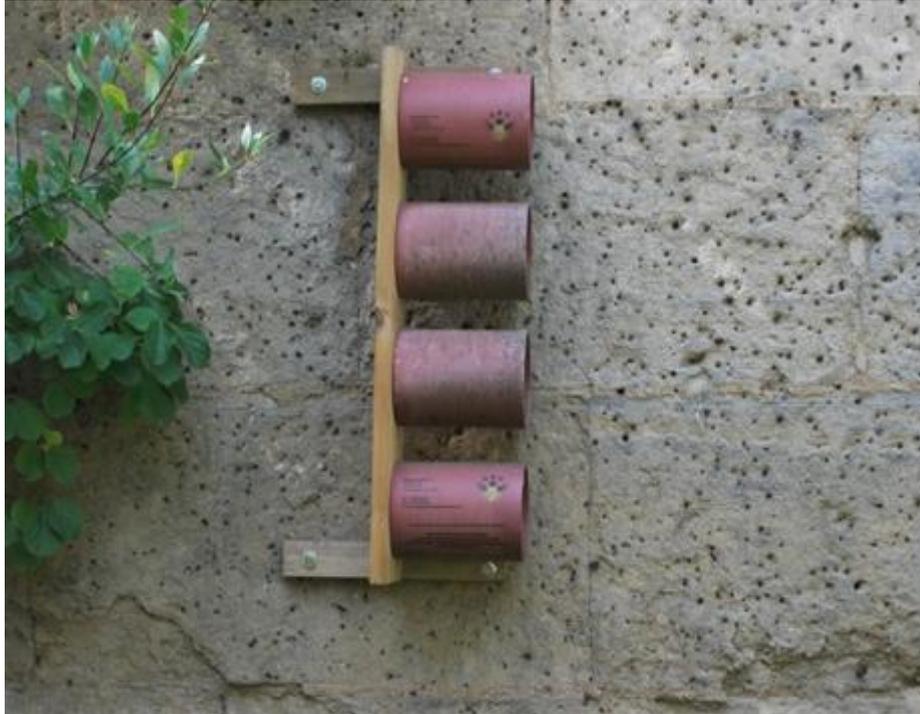
Fig 1c: Bee hotel located along the east-facing wall

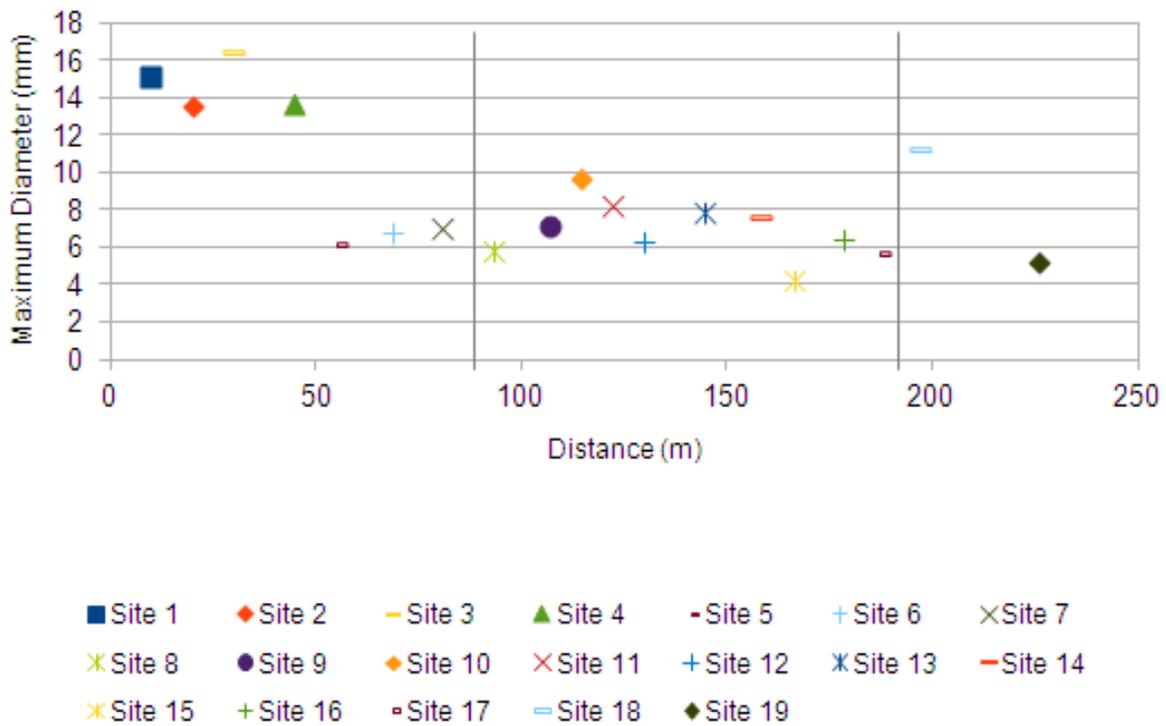
3. RESULTS: There seems to be an overall trend of decreasing average maximum pit diameter along the span of border wall sampled in this study. The largest measured pit was 23.41 mm in diameter found at Site 3 some 30 m along the wall; the smallest was 3.32 mm across at Site 15 some 160 m along the border wall. Average maximum pit diameter appears for each site in Fig:IIa. These are greatest in the first 50 m along the west-facing wall and drop from then to comparable (lower) levels along the remainder of the wall (including similar north- and east-facing sections). Nearly half of the points are within 6 and 8 mm in maximum diameter, with anomalies at Sites 8, 10-11, 15, 18-19.

Fig IIa: Pit diameter measured along the sections of border wall (west-, north-, and east-facing, respectively)

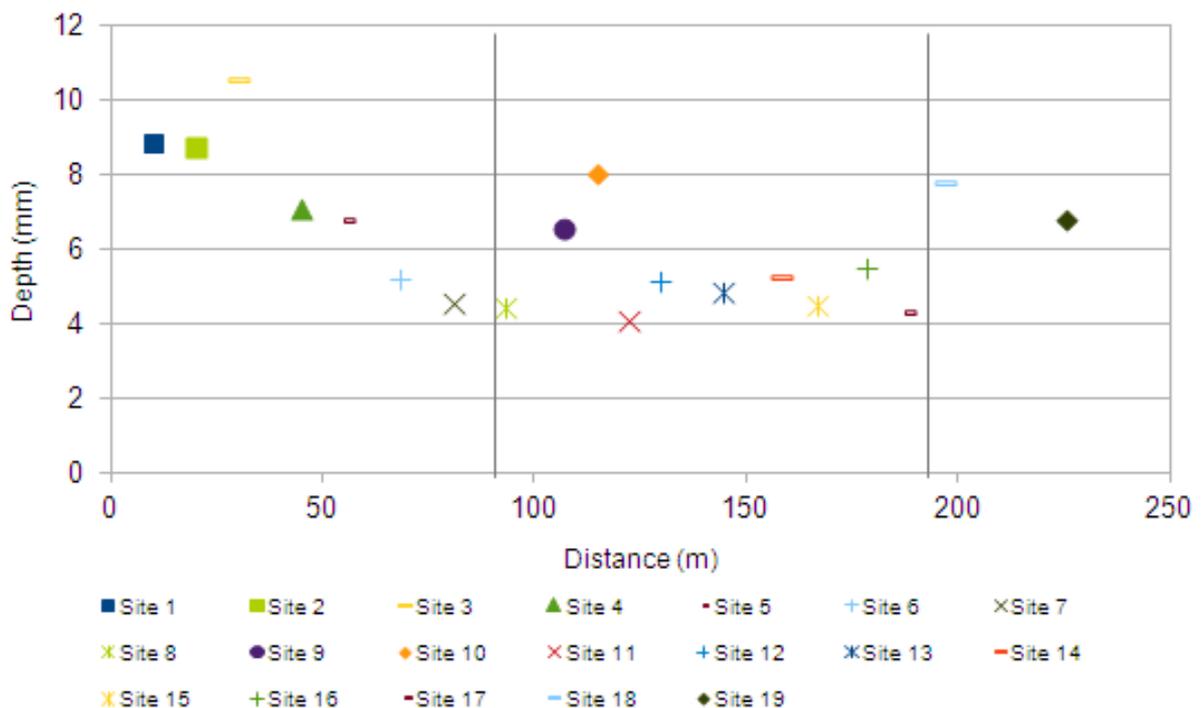
Similarly, average pit depth seems to decrease along the wall, with sets of exceptions. Pit depth seems to decrease along the wall (Fig:IIb), with the maximum depth within the first 50 m (up to Site 4). The deepest pit was located on the east-facing wall at Site 19; it was 76.76 mm deep. The least deep of the pits appeared on the north-facing wall nearby at Site 17; it was 0.78 mm in depth. The general average depth was between 4 and 6 mm apparent from Site 6 to Site 17, with some anomalies at Sites 4-5, 9-10, and 18-19.

Fig IIb: Pit depth measured along the respective sections of wall

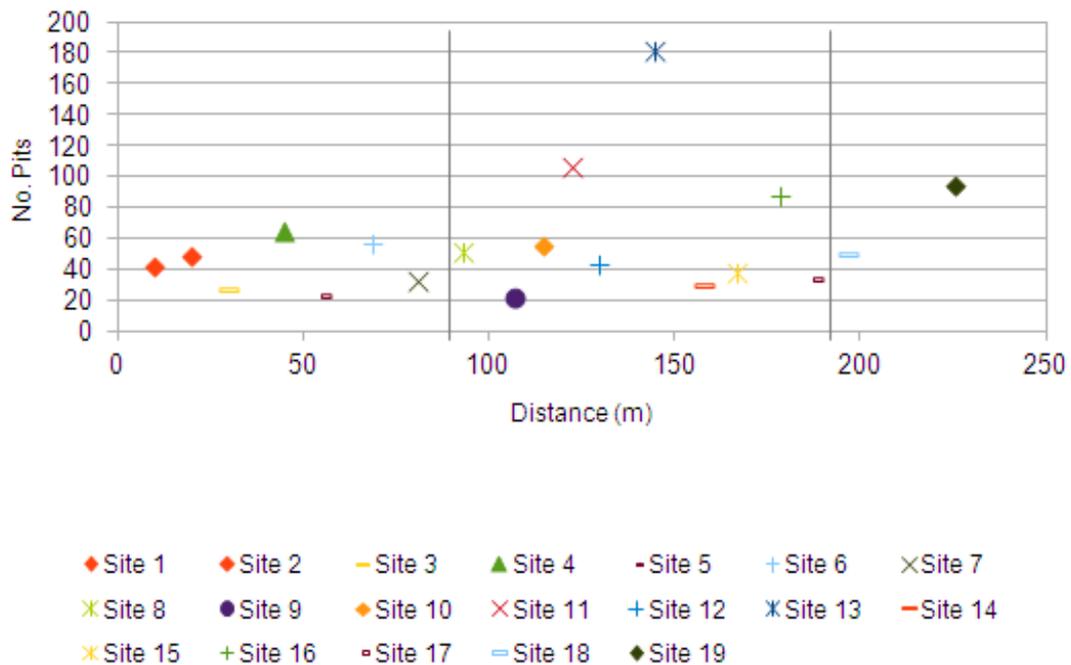
The number of pits counted per block seems to increase along the wall, with the lowest counts along the west-facing portion. These counts are generally between 40 and 60, with notable anomalies at Sites 11, 13, 16, and 19 (Fig:IIc). Unsurprisingly, pit density (pits/cm²) tends to increase along the wall, most notably from Site 11 on the north-facing wall.

Fig IIc: The number of pits counted per block along these sections of the old wall

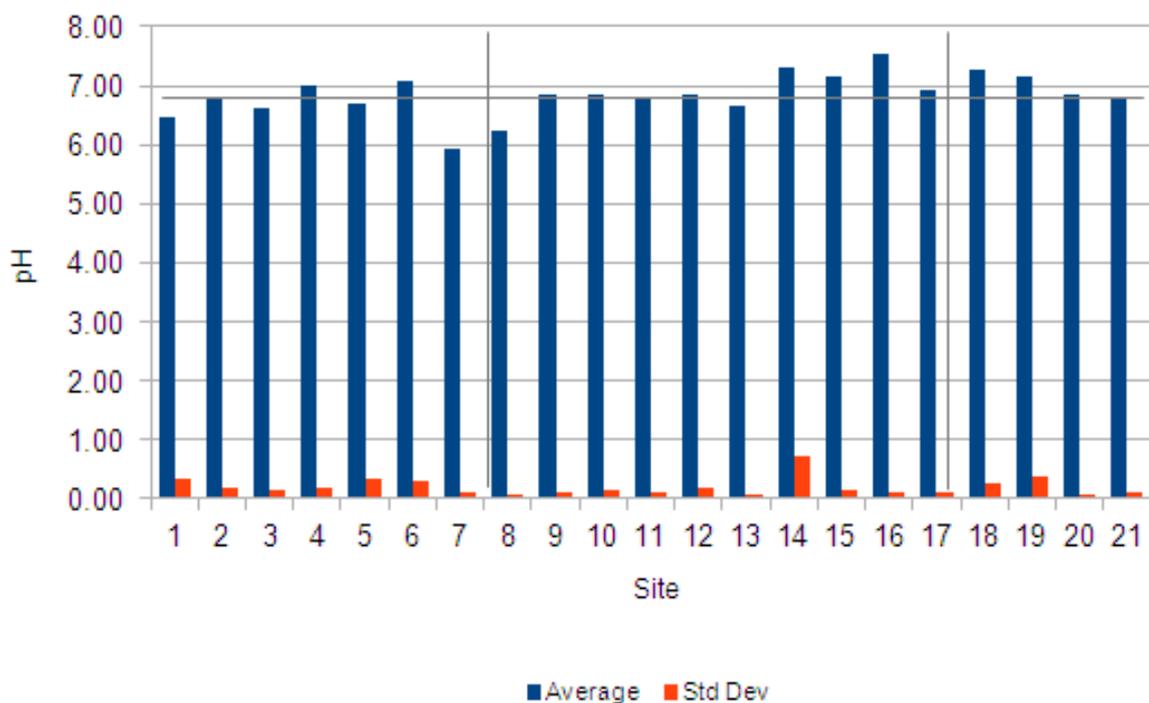
There was a general trend of increasing pH (reduced acidity) along the wall (Fig:IIIa), with $r = 4611$. However, this general relationship conceals orientational effects, such that pH increased along the west- and north-facing walls ($r = 0.7262$ and 0.8003 , respectively), but decreased along the east-facing wall, where $r = 0.9586$ (Fig:IIIb).

Fig IIIa: Acidity measured by pH along the west-, north-, and east-facing sections of the old border wall

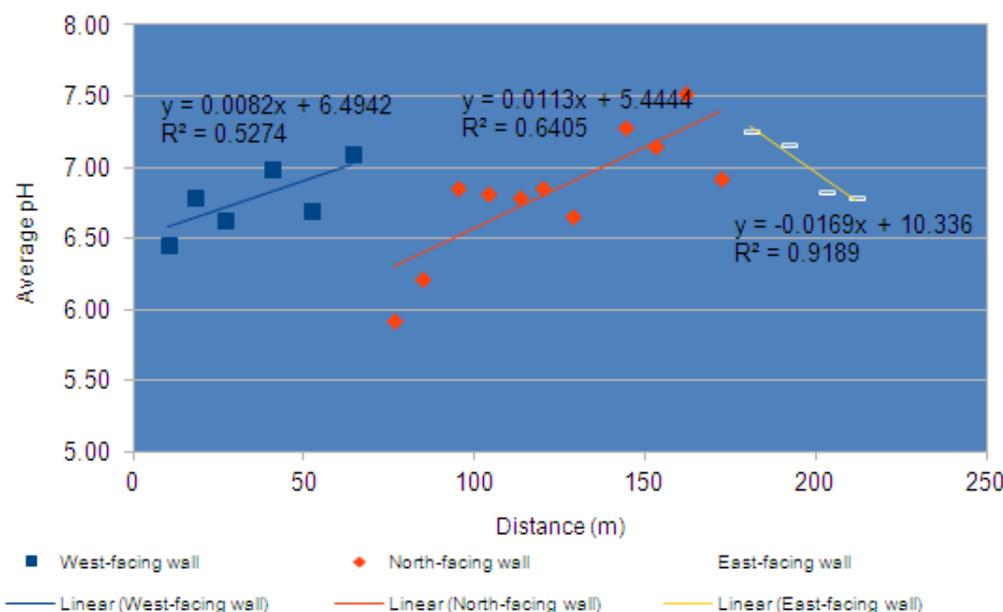
Fig IIIb: Linear correlation analysis of acidity along these sections of wall

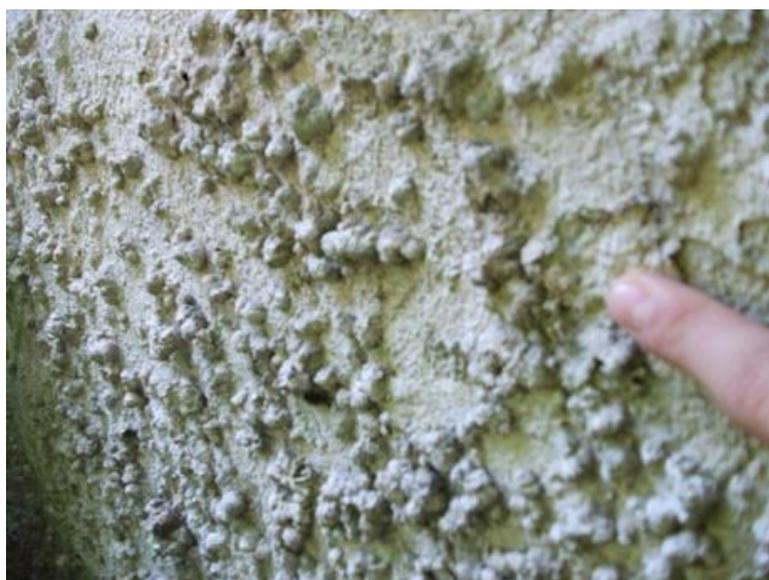
Fig IVa: Precipitates found along the back (north-facing) wall nearby to English ivy (*Hedera helix*)

Both the west- and north-facing walls are covered in climbing plants (ivies), including English ivy where precipitate is visible on the back (north-facing) wall. Using the chemical analysis (see Table:I) for guidance, it is possible to discern that crusts contain slightly higher proportions of CaO and SO₃ than precipitate, but that the

precipitate has an abundance of most of the other compounds tested, including Fe_2O_3 , K_2O , MgO , VM, and Sr. Higher concentrations of Ca is expected in crusts, but is also contained in precipitates, which comprise of Ca and Mg (hence, MgO). The sulfation process accounts for the high levels of SO_3 in crusts. The chemical signature is, therefore, not surprising. However, it is interesting that precipitates most noticeably occur in the vicinity of English ivy on the back wall (Fig:IVa). This could be attributed to the lower average pH evident in this section of the border wall. It is possible that English ivy in this section is secreting acids that are further acidifying the wall, resulting in the precipitation of Fe and Mg as well as Ca from its limestone fabric.

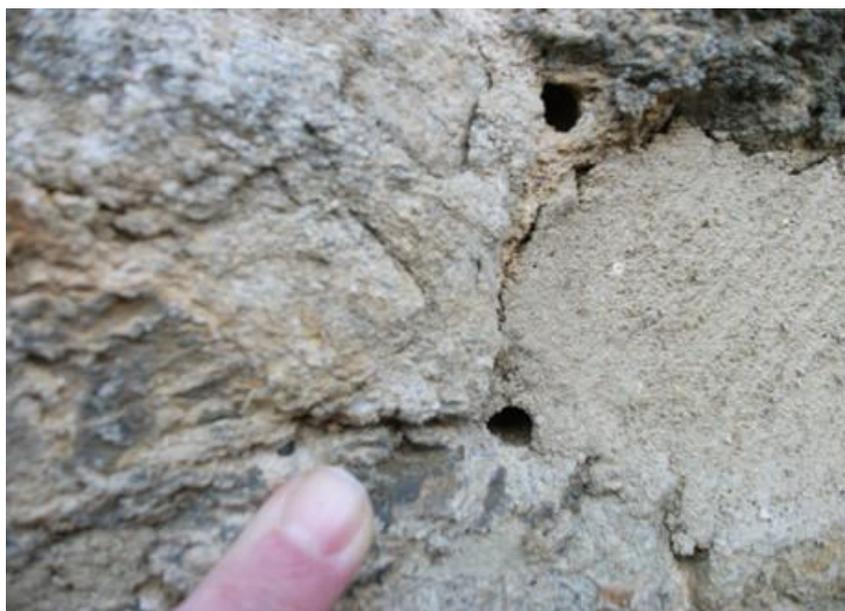
Where the enlarged pits are concerned, solitary (red mason) bees are likely culprits, as they are known to bore into soft material (e.g., mortar) to build their hives. These insects occupy pits (and enlarge them for their purposes) elsewhere in Oxford, as at Merton College (Fig:IVb). Other insects, such as spiders, are also known to occupy pits formed through dissolution in acidic environments such as this (e.g., spiders at the entrance of Worcester College, Oxford). However, it is noteworthy that the enlarged pits occurred throughout the surface of stone blocks (on hard stone, limestone in this case) and were not particularly located solely nearby mortar.

Fig IVb: Similar pitting observed on a different wall (belonging to Merton College, Oxford) known to be occupied by bees, with boring preference near to mortar
